TBR Sidewall Repair & Identification

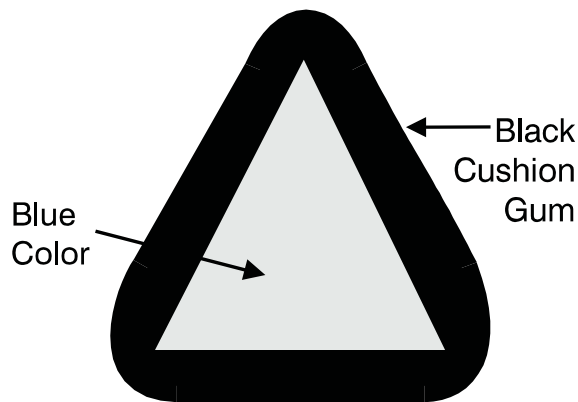
Sample Triangular Identification Patch

Note: Actual Size

In October 1990, the CVSA agreed to accept the use of a blue triangular identification adjacent to a sidewall repair bulge. A vehicle will not be placed out of service if a tire repair bulge is $\frac{3}{8}$ " or less in height and is identified with an adjacent blue triangle. The retread and repair industry will be incorporating these identification patches into their sidewall repair procedures.
